## INTRODUCTION

The city of Lake Park's Community Pool and Bathhouse facility has provided swimming and recreation opportunities to the residents of Lake Park and their neighboring communities since 1976. As a result of natural wear and tear over the past 47 years of operations, new building code regulations and ADA accessibility standards, the pool and bathhouse facility is in need of repairs and renovations/enhancements.

## BATHHOUSE ASSESSMENT

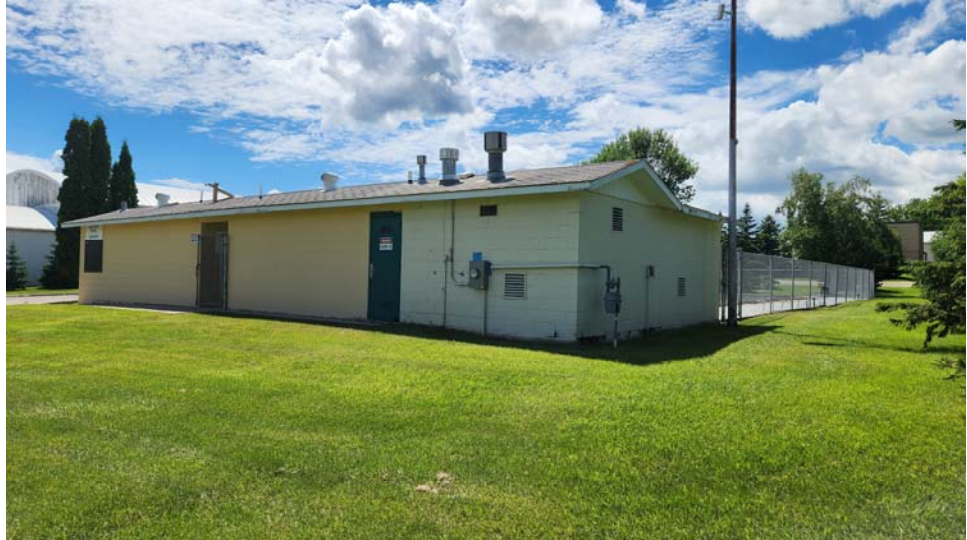
Image 1: *Exterior view of existing bathhouse*

The existing bathhouse facility has provided many years of service for the residents of Lake Park. As the results of natural wear and tear over the years, as well as, new building code regulations and accessibility standards, the bathhouse facility is in need of repairs and renovations.

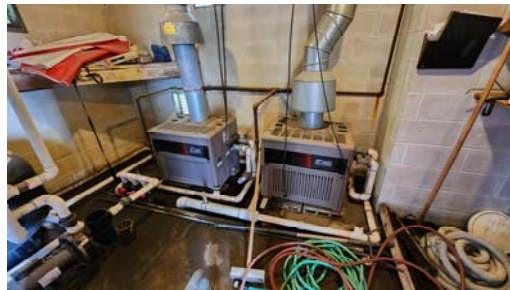
Pump room was a later addition to the original bath house during the 1990's renovation which filled in the kiddie pool.

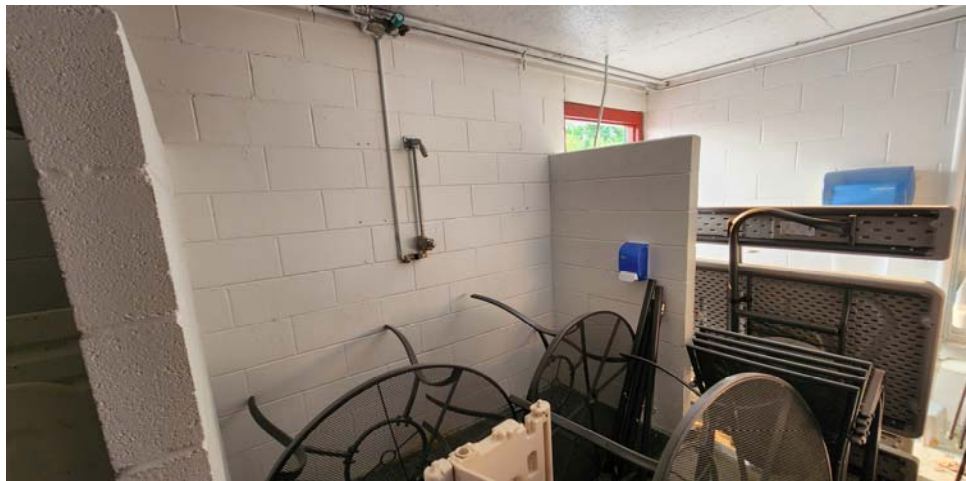
Given the building's age, it was found to be in fair condition. Investigation of the interior found minor cracking at wall intersections and floor penetrations which is common for a building of this age.

Image 6: *Men's Interior Shower View Minor cracking on wall*

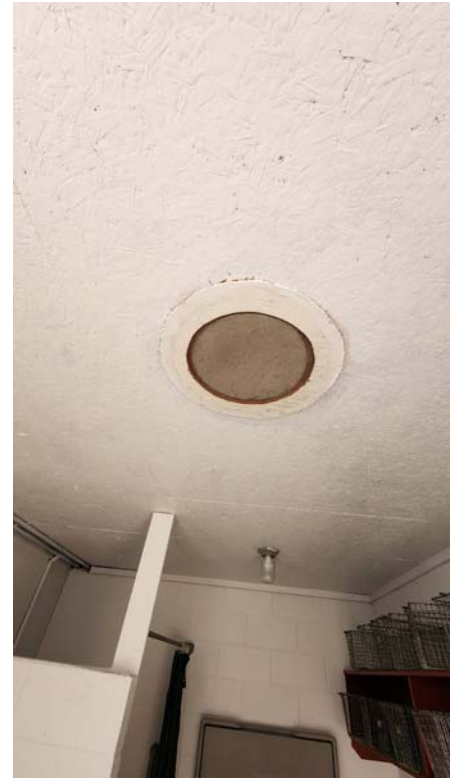
Image 7: Women's Interior Toilet View Minor cracking on wall and curtain as door  
Image 8: Women's Interior Ceiling View showing painted chip board and sealed vent/light well with plastic.

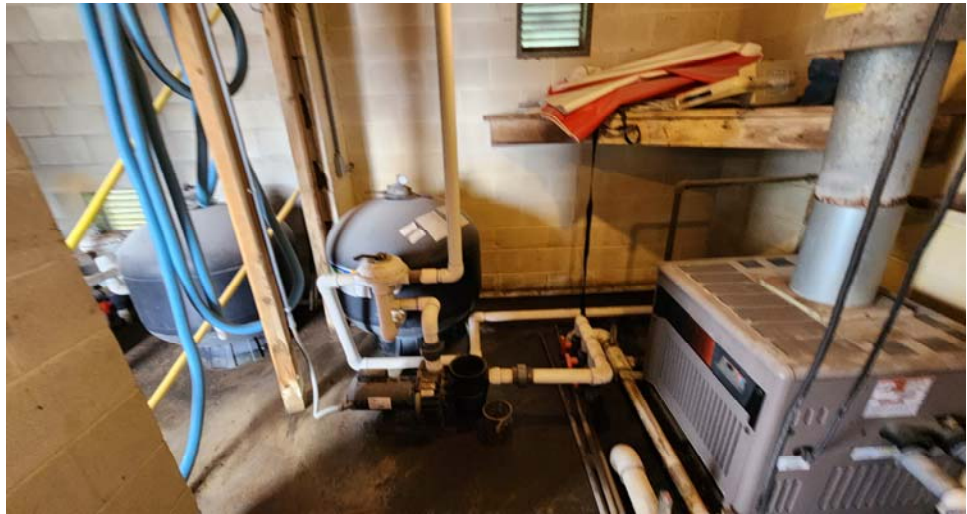
Image 11: Pool Mechanical Interior showing outdated pool mechanical and heating systems.

5. Remove existing pool mechanical equipment and replace with new recirculation pump, disinfection system, chemical controller and water level controller with piping and valves.  
Estimated Cost: \$103,000

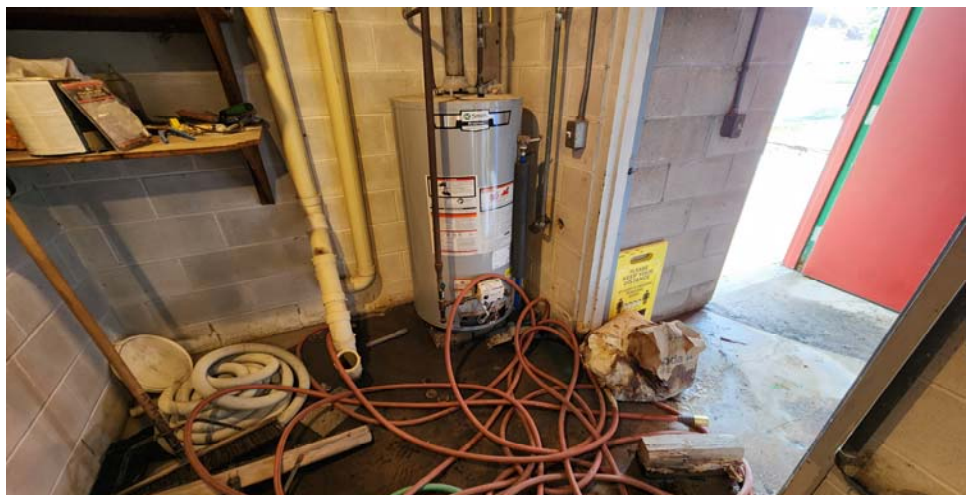
Image 12: Pool Mechanical Interior showing outdated pool mechanical and heating systems.

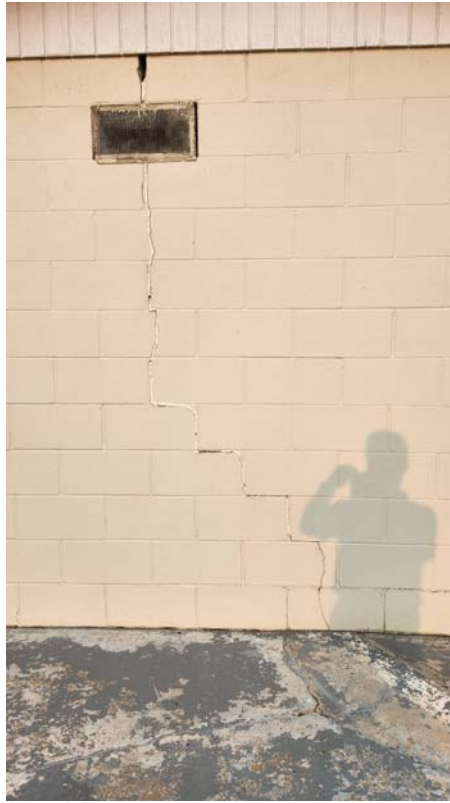
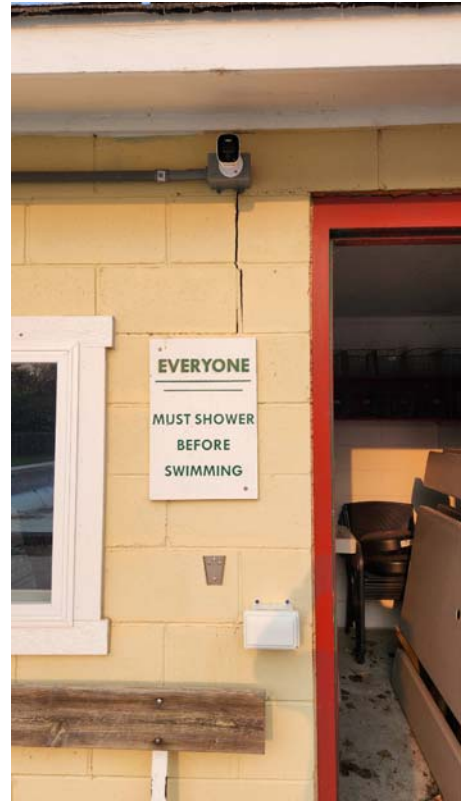
Investigation of the exterior discovered multiple cracks in the masonry walls, indicating differential movement of the foundation.

Image 13: South exterior wall of pool mechanical room showing masonry cracking due to differential shifting of the wall as there are two different substrates the current wall sits on.

Image 14: South wall between admissions and boy's locker room showing cracking due to differential foundation movement.

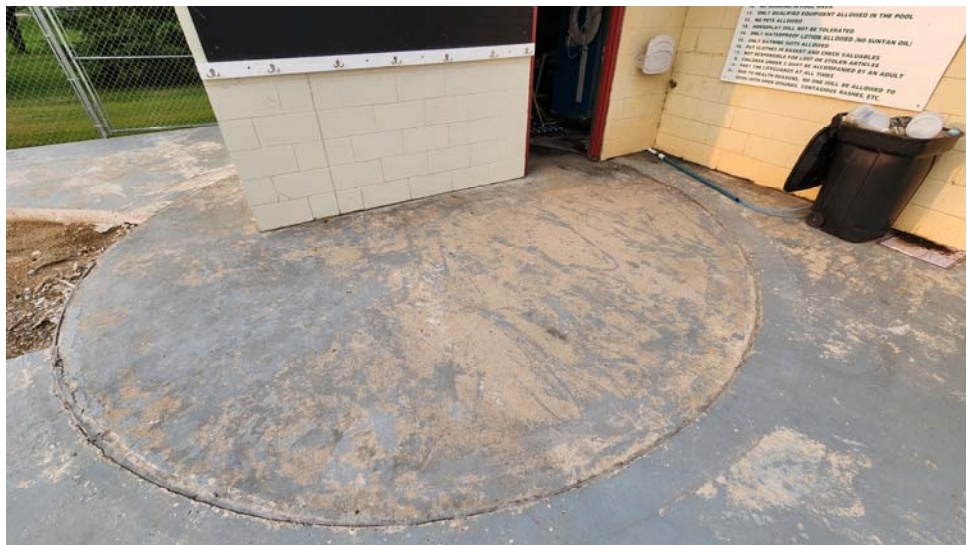
Image 15: Exterior view of Pool House showing the west addition sitting on top of The old kiddie pool resulting in differential movement of the building shell which in turn has caused the masonry wall to crack. Refer to image 13.

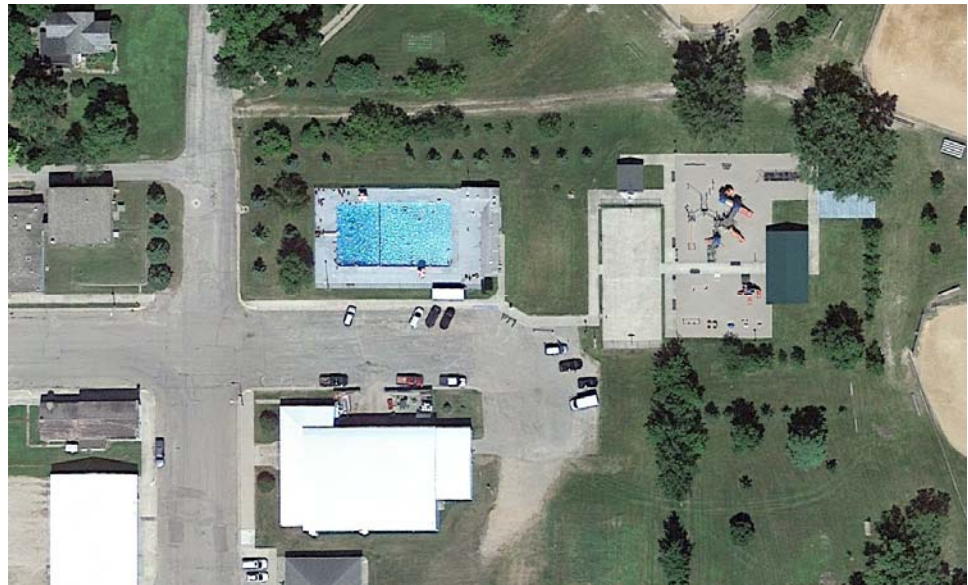
Image 16: 2019 Site image taken from google earth

*Off street parking for the pool facility is not provided on site, there is however, space for two accessible parking stalls directly to the east of the picnic shelter along the property's south boundary. This space will be required to be striped to show 2 identifiable accessible parking stalls, one being Van Accessible and posted with signs. Currently, pool patrons are utilizing the diagonal on-street parking along the south property line of the existing pool facility. This parking is not striped and appears to accommodate around 25 vehicles.*

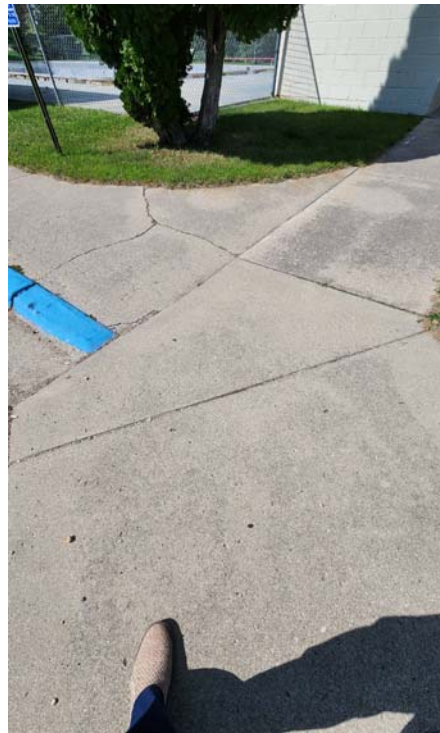
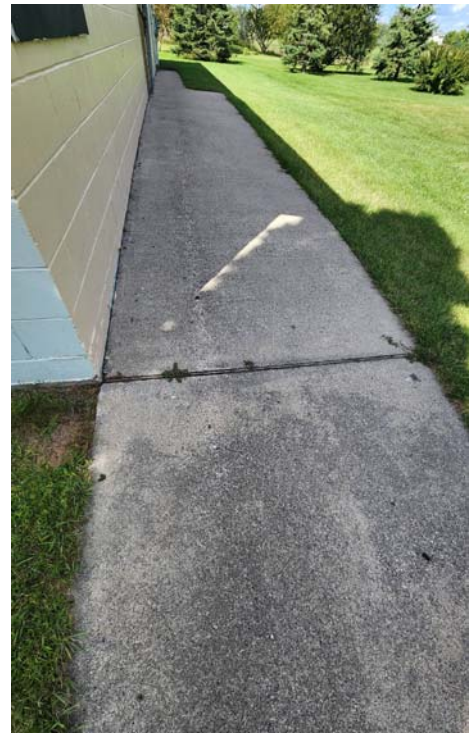
*The existing route from the accessible parking stalls to the front of the bathhouse is a firm, stable and slip resistant concrete surface with minor to moderate cracking and slab uplift at control joints that will need to be addressed by either removal of damaged concrete or grinding to level off uneven control joints.*

Image 17: Existing accessible path to pool entry showing cracking. Note: current path does not meet approved ramping from street parking to accessible sidewalk.  
Image 18: Existing sidewalk showing control joint transition along accessible route.

11. Install accessible sidewalls from accessible parking to pool facility.  
Estimated Cost: \$ 6,500

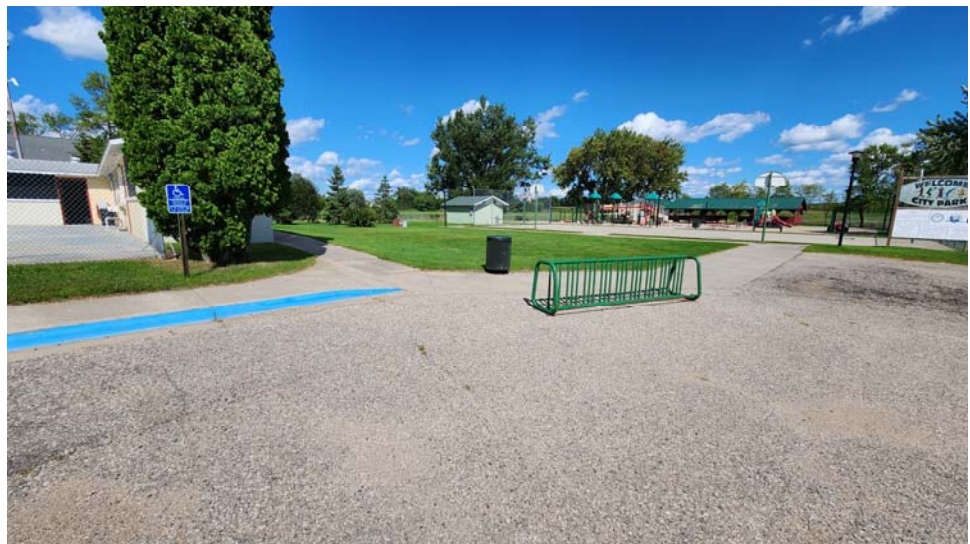
*Appropriate signage with the international symbol of accessibility is required to be posted either on a sign post / building / or fence directly in front of the parking stall, centered on said stall at a height of 6 feet from pavement to bottom of sign.*

Image 19: view of accessible parking stalls with signage. relocate bike rack to make room for wheelchair accessible route.

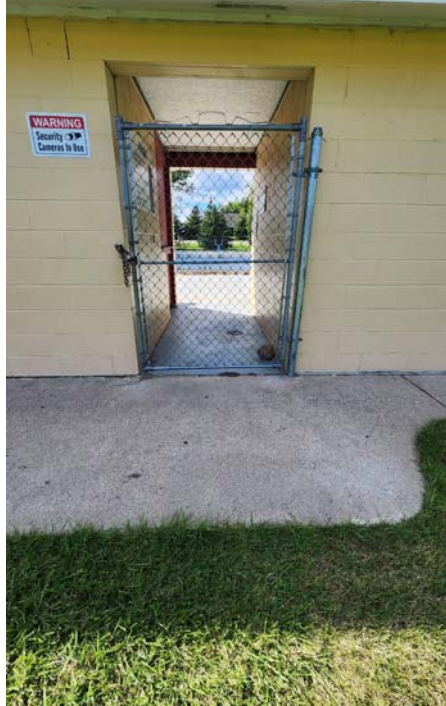
There are six (6) entrances/exits to the building. The East Entrance is the “main” entrance and is for the admission of pool patrons. This door/gate is a chain-link, four-foot-wide panel held open during operating hours. The other east facing door enters the chemical room and is not required to be accessible. The West and South facing doors are for the girl’s and boy’s changing room and the South facing door is for the pool pump room.

Image 20: view of front entrance entering pool facility.

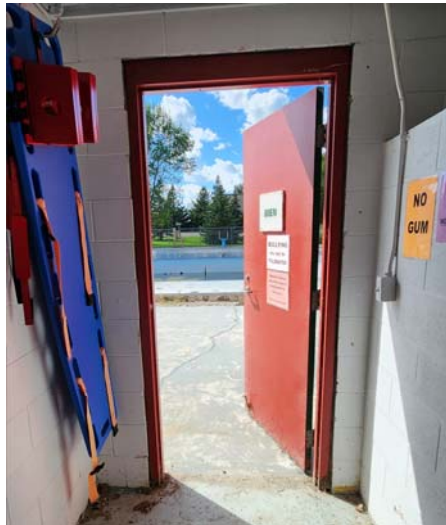
Image 22: Boys Changing Exit

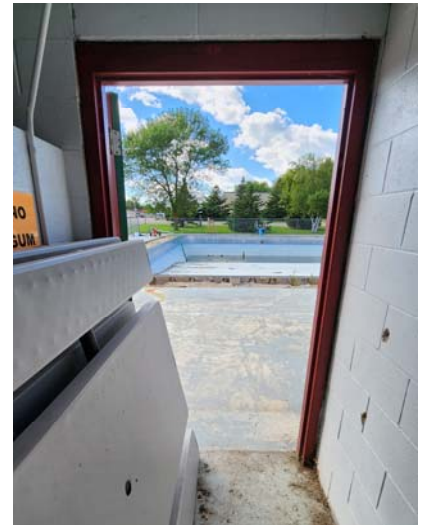
Image 23: Girls Changing Exit

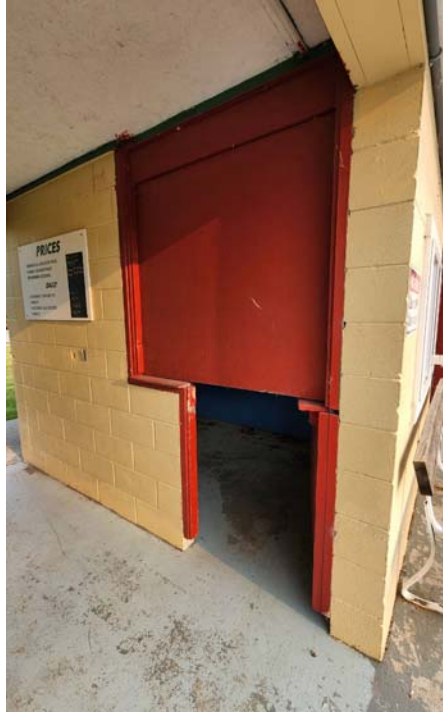
*The minimum requirement for an accessible route is 36" wide with minimum clearances of 12" push side and 18" pull side at doors. Currently only the boys changing room has an accessible route meeting both entering and exiting of the room.*

Image 24: View of admissions at entrance corridor.

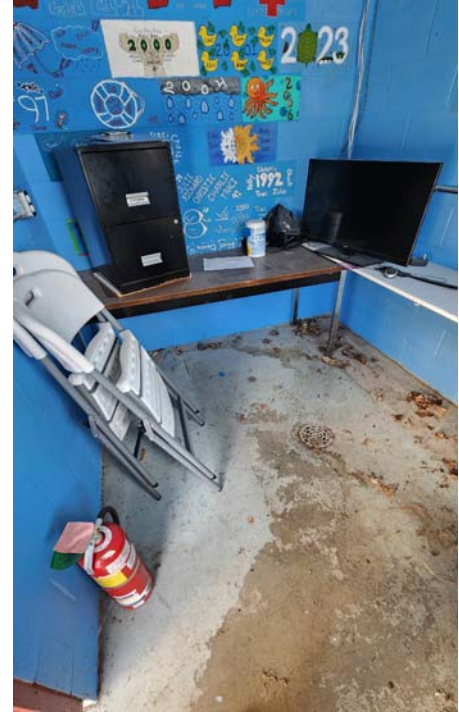
Image 25: View of the interior of admissions.

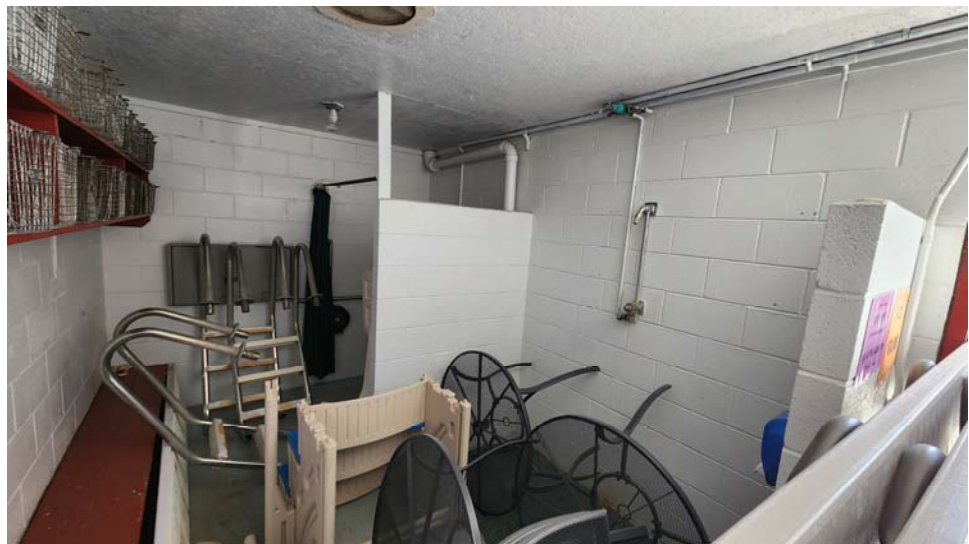
Image 26: View of the interior of the Girl's changing room.

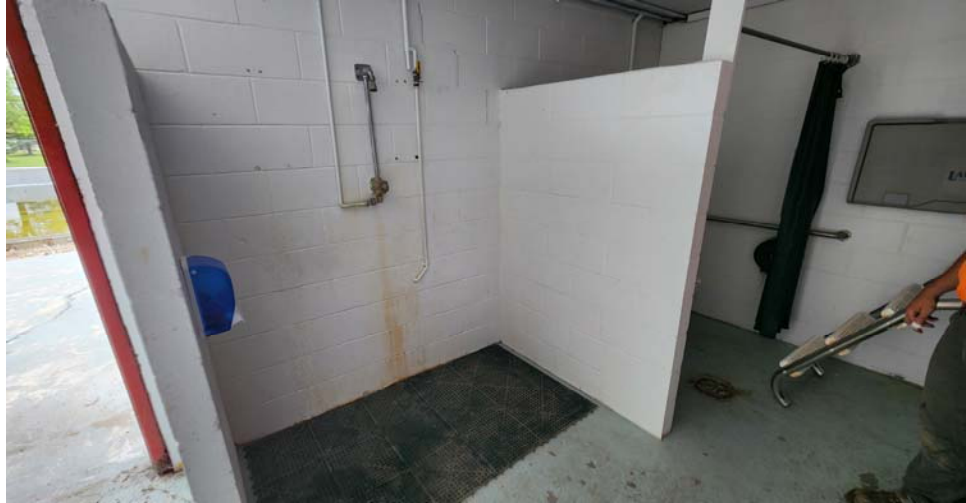
Image 27: View of Boy's changing room

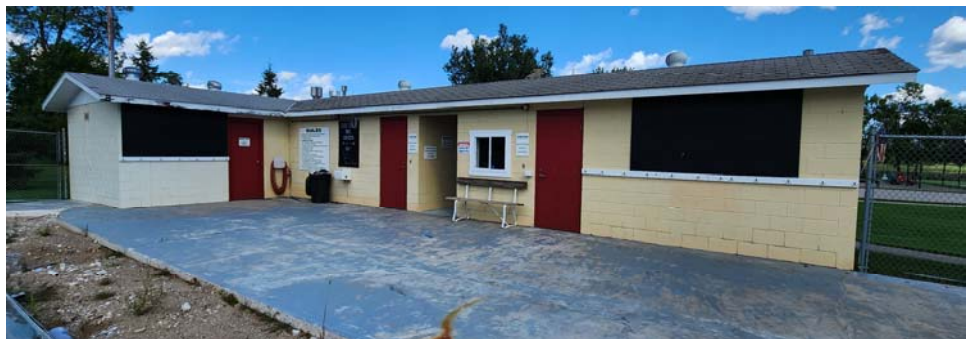
*All doorways meet the minimum clearance requirement of 32 inches wide when fully opened. However, the doors exiting the girl's changing rooms from the changing room side does not meet the required 12/18-inch push/pull clearance requirements. The Front entrance (east side) meets width requirements. Doors entering/exiting the chemical room and the filter room are not required to be accessible. The door exiting/entering the office (admissions) area from the pool does meet accessible guidelines.*

Image 28: View of pool pump room door (south facing), Boy's and Girl's changing room doors (boy's on left) and front entry corridor between changing room doors.

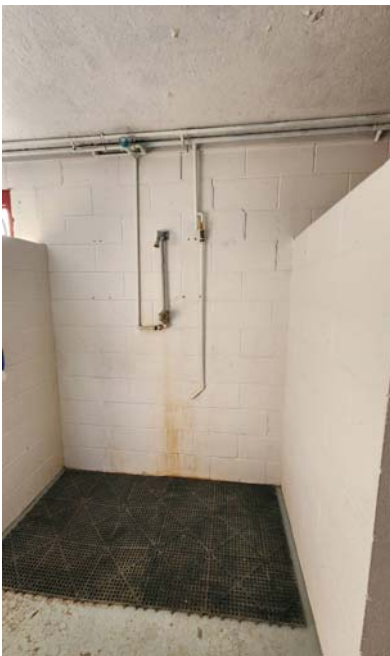
**Showers:** Do not meet accessible clearances to accommodate a wheelchair. The shower controls present a burn hazard.

**Routes:** Only the boy's changing room has an accessible route to or from the pool and/or entrance.

Images 29-33 Interior views of changing rooms

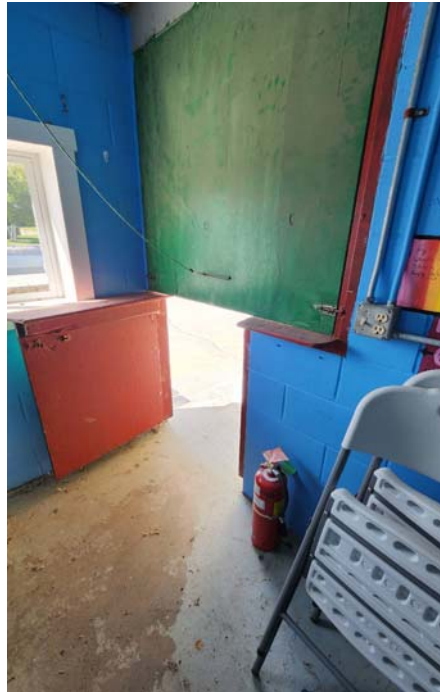
Image 34: Interior view of admissions counter

*Height of counter top is approx. 3'-6". A portion of the counter is required to be at 36" high for a minimum of 3 feet long. Clear floor area in front of counter is insufficient to meet accessibility requirements.*

2. Enlarge admissions office to include accessible counter per building code.  
Estimated Cost: \$ 32,500
3. Increase entry hall width to a minimum of six feet wide to accommodate two-way traffic  
Estimated Cost: \$ 10,000

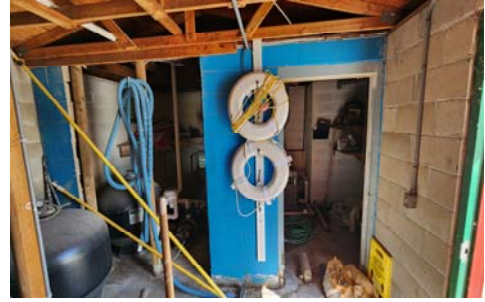
**Plumbing:** *Plumbing systems in this area appear to be adequate for the existing pool system and facility's needs, however, these systems appear to be in below average condition.*

**Water Heaters:** *Water heaters are residential tank type heaters and should be replaced with commercial style water tanks.*

**Electrical Panel:** *Poor condition, inadequate and should be replaced.*

Image 36 &amp; 37: Interior views of the filter room

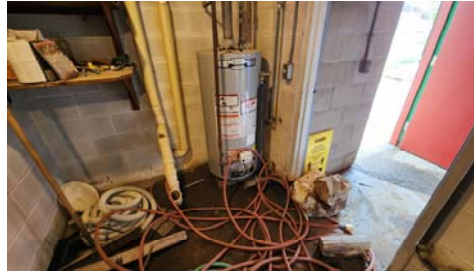
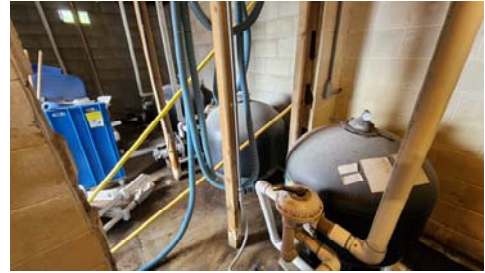
Image 38 &amp; 39: Interior views of the filter room

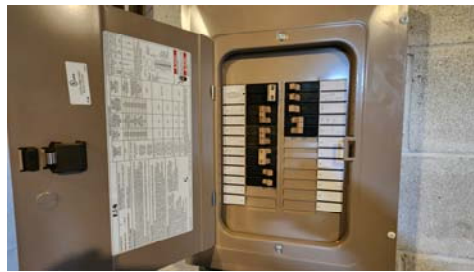
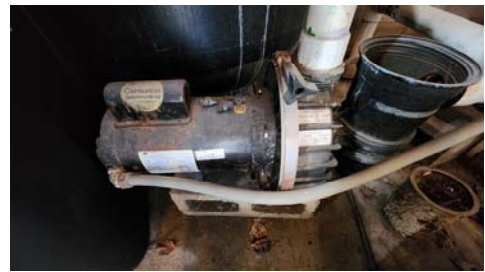
Image 40 &amp; 41: Views of Electrical Panel and one of the pool pumps.

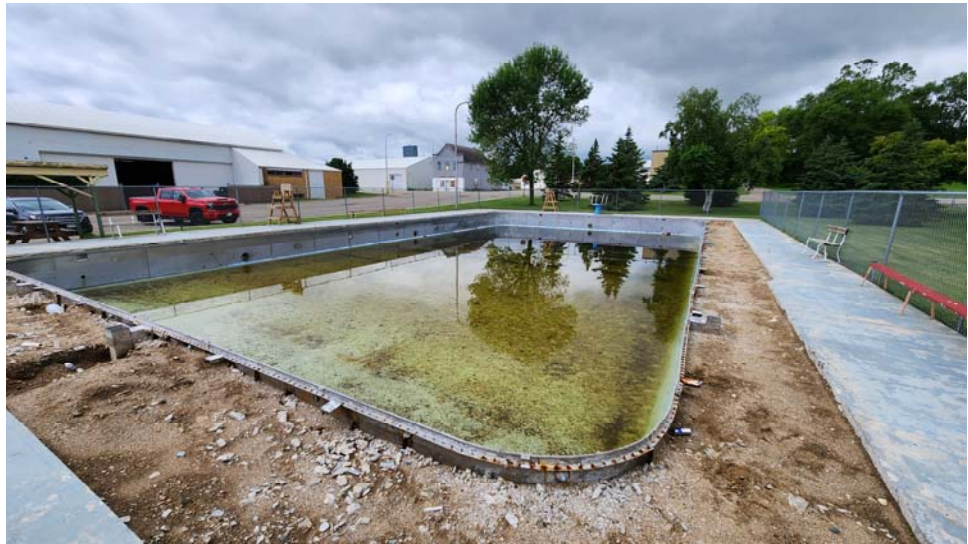
*An approximate 4-foot-wide ring of the concrete pool deck has been removed to inspect the pools surrounding plumbing, grounding grid and structural integrity. The remaining concrete deck is a firm, stable and slip resistant surface with minor to moderate cracking with some slab uplift at control joints that will need to be addressed by either removal of damaged concrete or grinding to level off uneven control joints. At this time there are many areas around the pool deck that could possibly contribute to physical injury of users by uneven slabs becoming tripping hazards and toe stubbers. Pool deck will need to be removed if the city decides to repair the underground piping and pool perimeter coping. This last spring the City of Lake Park decided to close the pool due to the facilities aging infrastructure, outdated and failing mechanical systems.*

Image 42: Perimeter edge of Pool

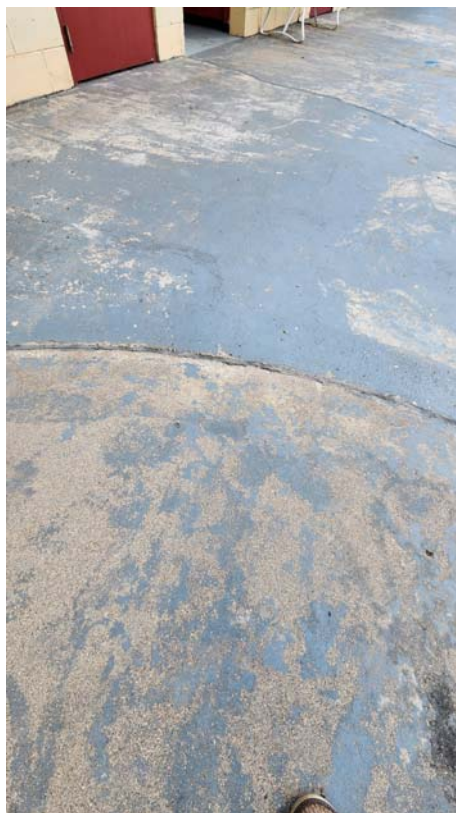
Image 43: Kiddie pool infill

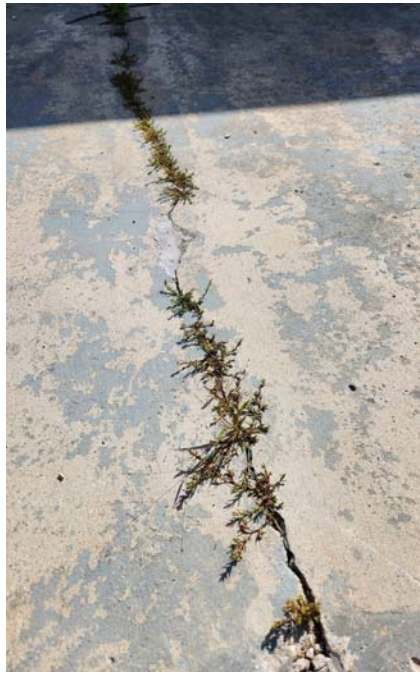
Image 45: Pool deck crack

8. Install new shingles.  
Estimated Cost: \$ 19,500
9. Install new chain-link fence enclosure around pool deck.  
Estimated Cost: \$ 12,600
10. Install new 4-inch concrete pool deck.  
Estimated Cost: \$111,800

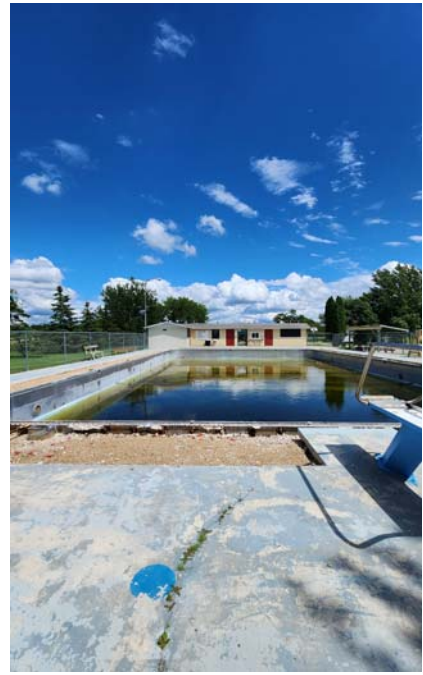
Image 46: Pool deck crack

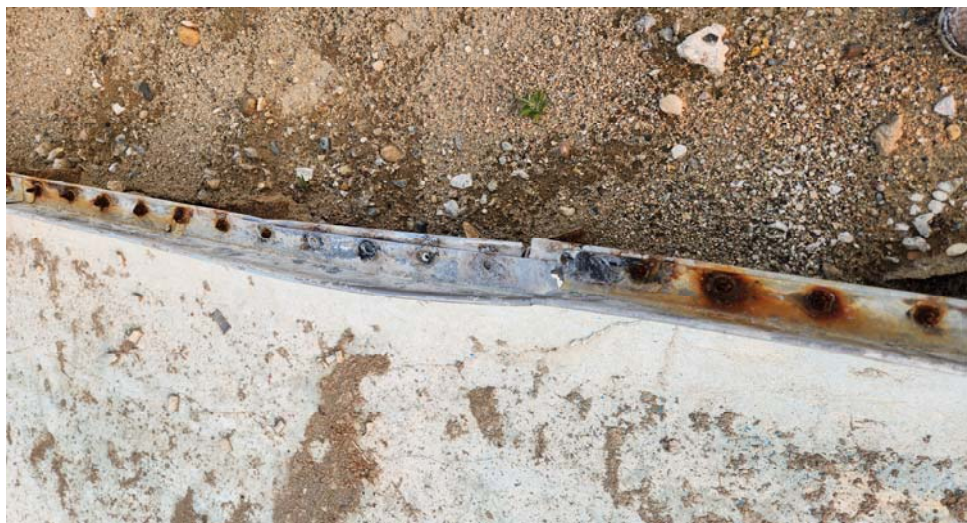
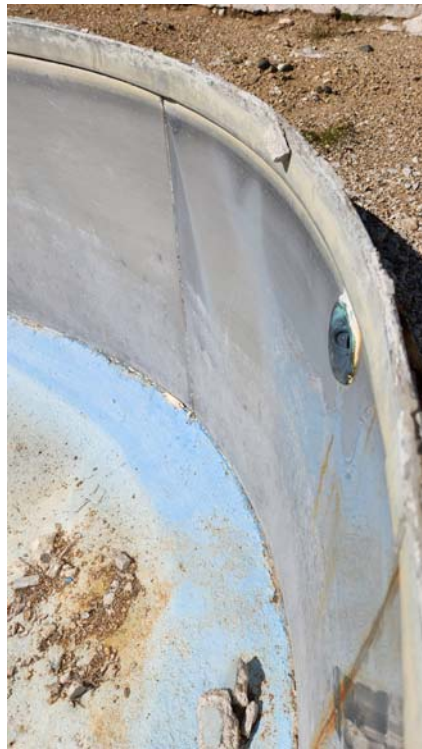
- a. Age of the stainless-steel wall panel system and integrity of its structural tieback system.

Image 47: view looking straight down showing damage to top of stainless-steel pool wall.

Image 48: view looking at warped stainless pool corner.

Image 49: view of back side of stainless-steel pool panels missing vertical bracing and horizontal tie rods.

1. Cover existing stainless steel wall panels and concrete floor with 8 inches of shotcrete while using the existing stainless steel wall panels and concrete floor as a back form. (overall pool size will be reduced)  
Estimated Cost: \$400,000

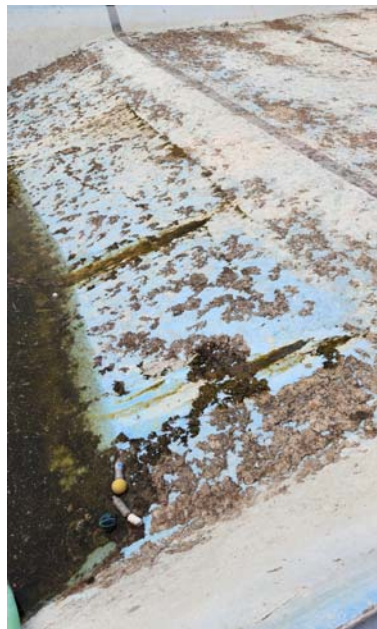
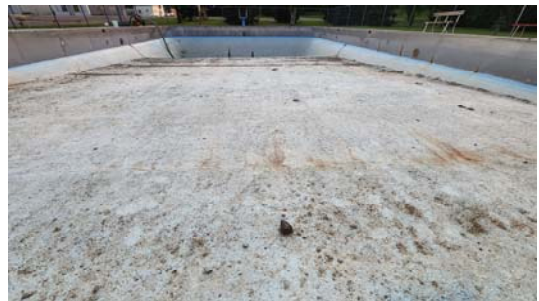
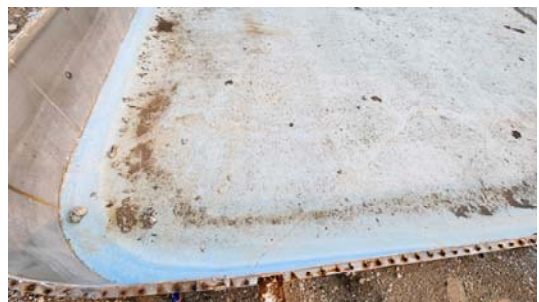
b. Poor condition of the pool floor structure with extensive cracking.

Image 50,51 & 52: different views of the pool floor structure

8. Core boring analysis of the pool basin is recommended to assess the integrity of the concrete structure to help identify extent of necessary repairs / replacements if renovation of pool is desired.

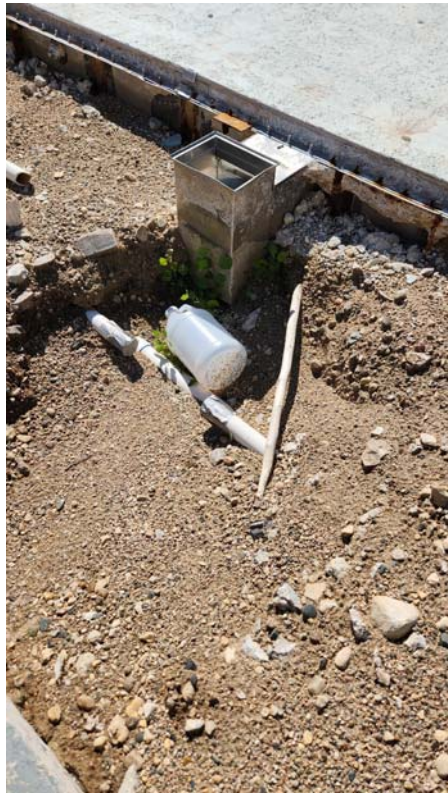
Image 53: View of skimmer and associated plumbing

2. Replace existing skimmers with new skimmer inlet recirculation system along with piping / wall inlets to filter room. Install new mortex formed coping edge / waterline tile to tie in with new concrete perimeter deck construction.  
Estimated Cost: \$275,000

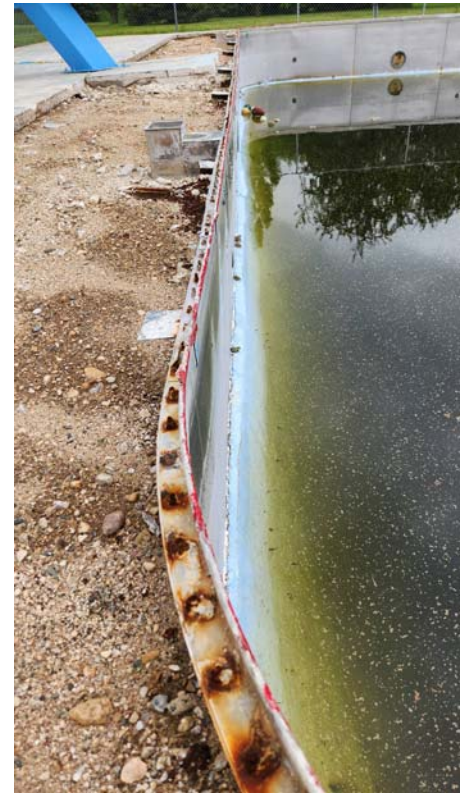
Image 54: View of West side of pool by diving board

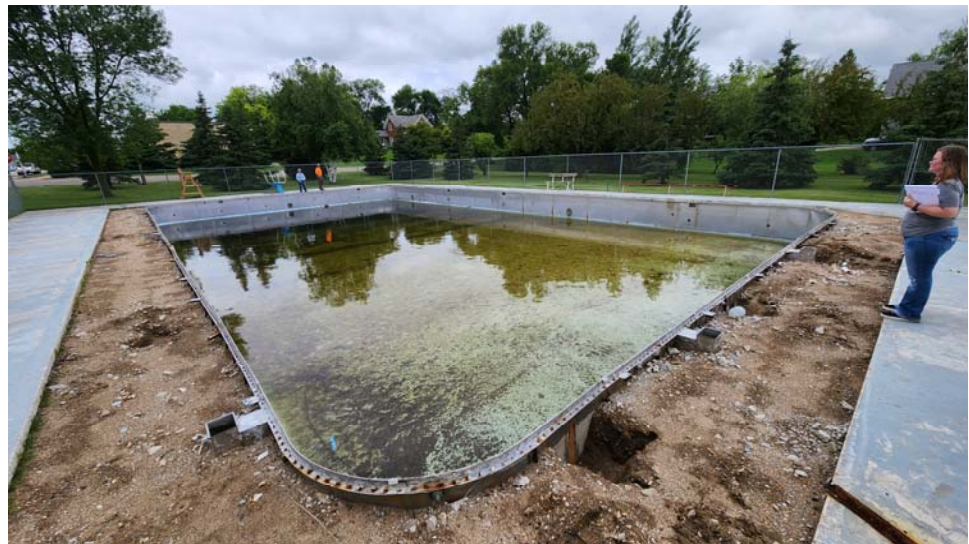
- c. Pool is not in compliance with industry safety standards, Americans with Disabilities Act (ADA), Pool and Spa Safety Act – Anti Entrapment (VGB), Minnesota State Health Code and 10 State Aquatic Design Standards.

Image 55: View of existing conditions of pool

3. Apply an epoxy paint finish to the floors and walls.  
Estimated Cost: \$110,000
4. Replace existing main drains with Anti Entrapment VGB compliant sumps, grating and underground piping to filter room.  
Estimated Cost: \$70,000

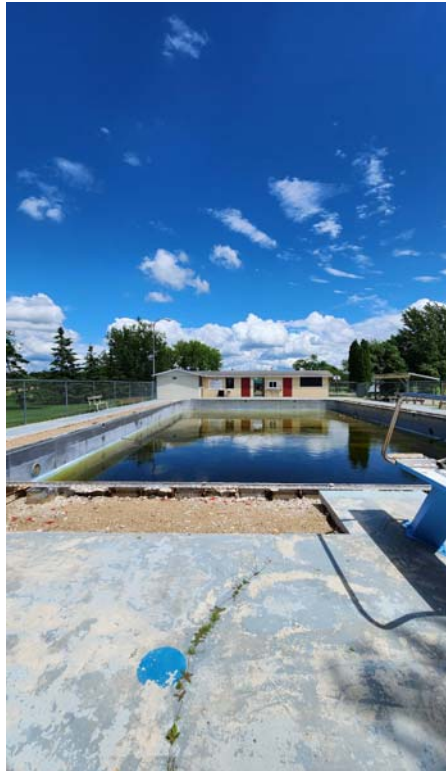
- d. The existing pool is outdated and does not meet today's construction standards or leisure water amenities / components that communities are expecting from swimming pools.

Image 56 & 57: View of current pool facility and diving board

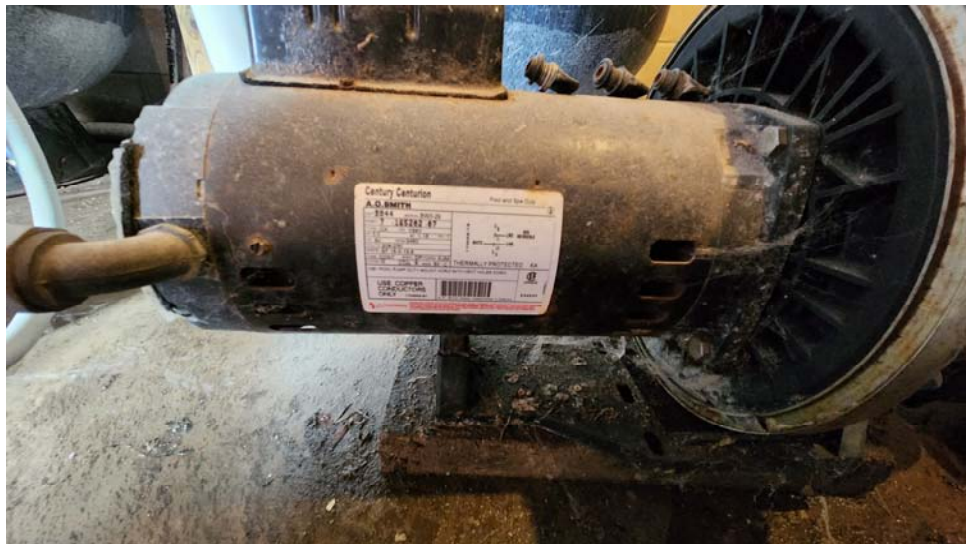
- e. Increased costs associated with current operation and maintenance under existing conditions.

Image 58: View of one of the many pool pumps.
